HISTORICAL EVOLUTION AND PRESERVATION OF THE LIPTHAY MANSION PARK IN LOVRIN

Abstract: The Lipthay Mansion in the village of Lovrin, once owned by the Lipthay noble family, is a representative example of architectural and landscape heritage in Banat, Romania. Within the broader regional context, where over 70% of historical landscapes have been significantly altered or completely destroyed during the political transformations of the 20th century, this site stands as an exceptional example of preservation and historical continuity. This study analyzes the evolution of the mansion and its park based on historical research, topographic maps, cadastral surveys, and direct observations of the current state of the estate. The research examines and documents how the site has maintained its spatial integrity and original boundaries despite significant political and social changes in the region, while most similar properties have been severely damaged or fragmented. The study identifies factors contributing to the preservation, including the estate's integration into the urban fabric of Lovrin. The findings contribute to broader understanding of heritage conservation practice in the Banat r

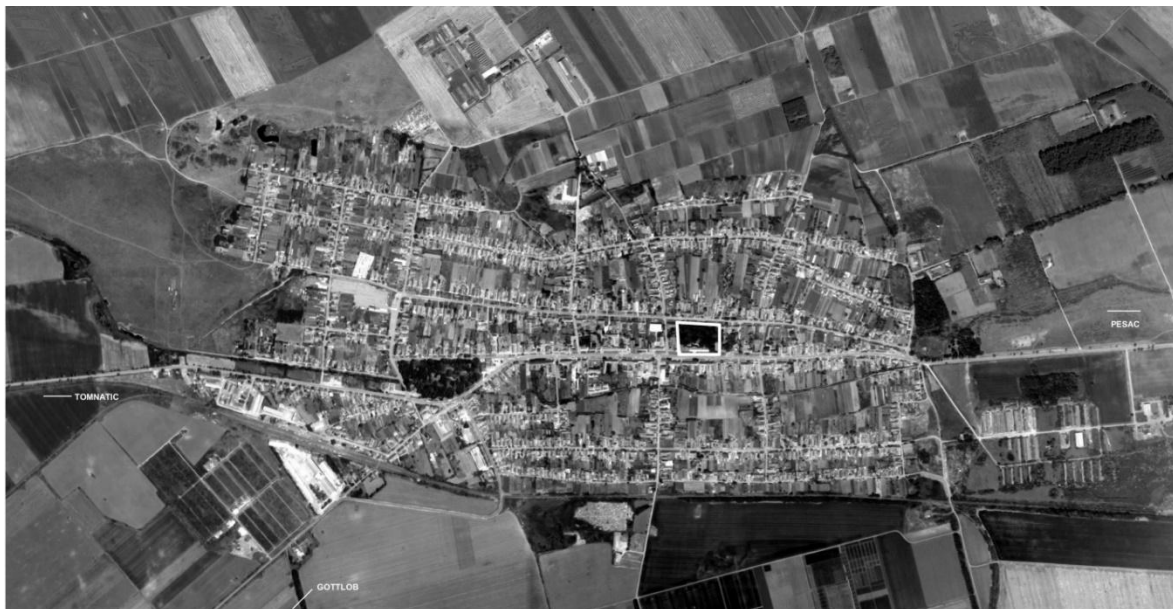
Fig. 1. Ortofotography of Lovrin (2024), showing the Liphay Mansion complex boundaries (white contour). The preservation of original dimensions is rare among regional historical estates, particularly given the widespread subdivision during post-communist era.

Lovrin is located in Timiș County, Romania, along national road DN6. The Liphay Mansion sits in the village center with frontage on both the national road and a park behind the mansion. This location has remained consistent throughout history according to historical maps (**Fig. 1**).

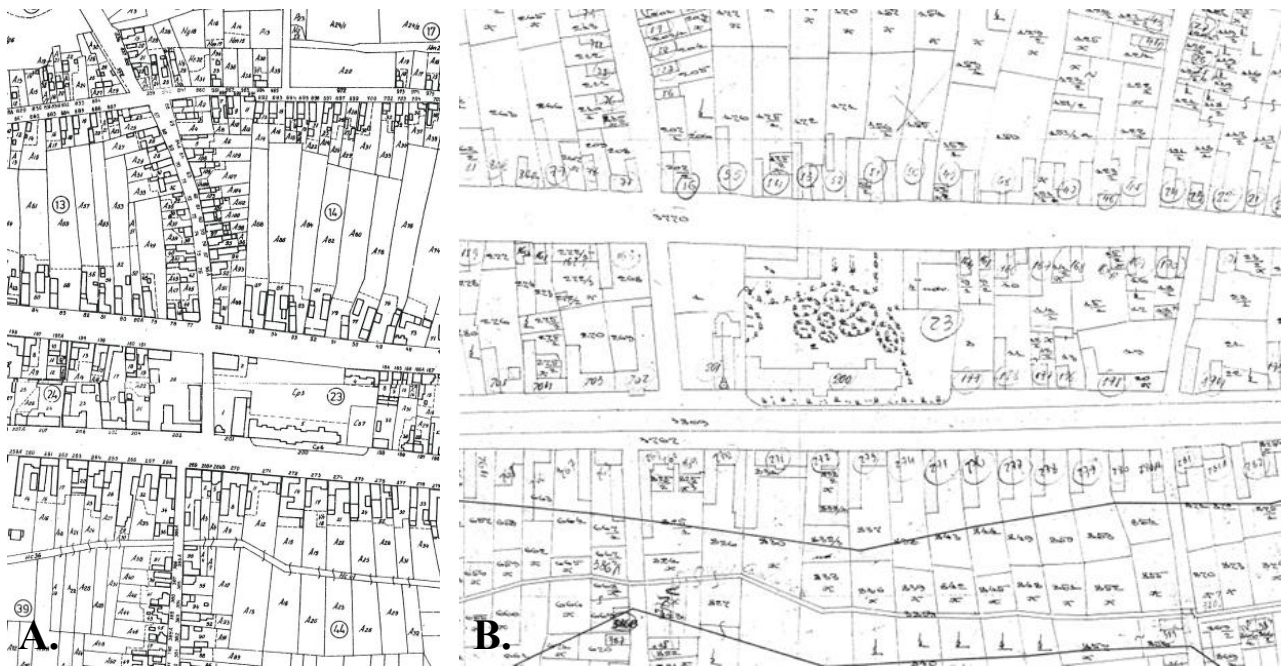
Fig. 4. Fragment of cadastral map from 1899 (The Office of Land Registry and Real Estate Advertising Timiș), providing detailed information about property boundaries (A.), vegetation patterns, and built structures that have informed our understanding of the estate's historical organization and subsequent preservation (B.).

Regarding the arrangement of major elements on the site, the cadastral map of 1899 shows changes in the rear area of the estate compared to earlier topographic maps. The representative alleys depicted in the

topographic maps disappear, and the cadastral map instead shows areas with dense vegetation arranged in a circular pattern, suggesting intentional landscape design with tall vegetation and "alleys" or paths that were planned and can still be identified today. This evolution reflects changing landscape tastes and functions, yet remarkably, the basic spatial organization has been maintained (Figures 5-6).

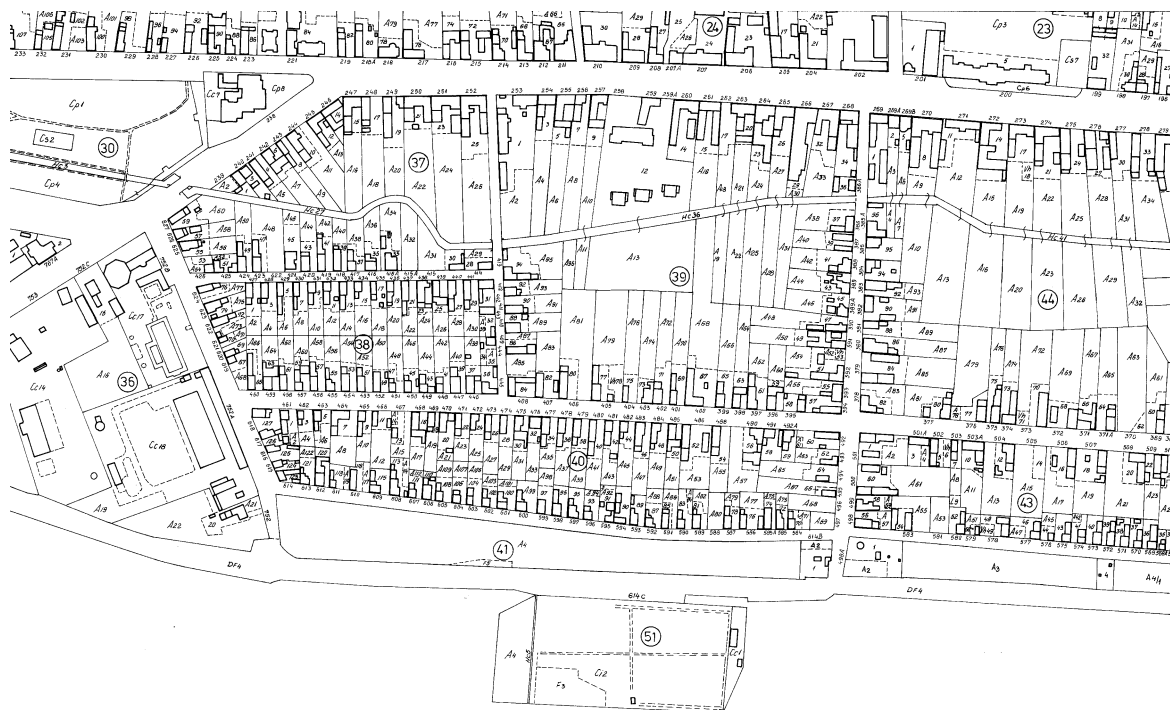
Fig. 6. Fragment of cadastral map from 1988, Scale 1:2000 (The Office of Land Registry and Real Estate Advertising Timiș), showing minimal changes to the estate's organization in the late 20th century, further supporting the site's value as an example of exceptional preservation in a period of rapid change.

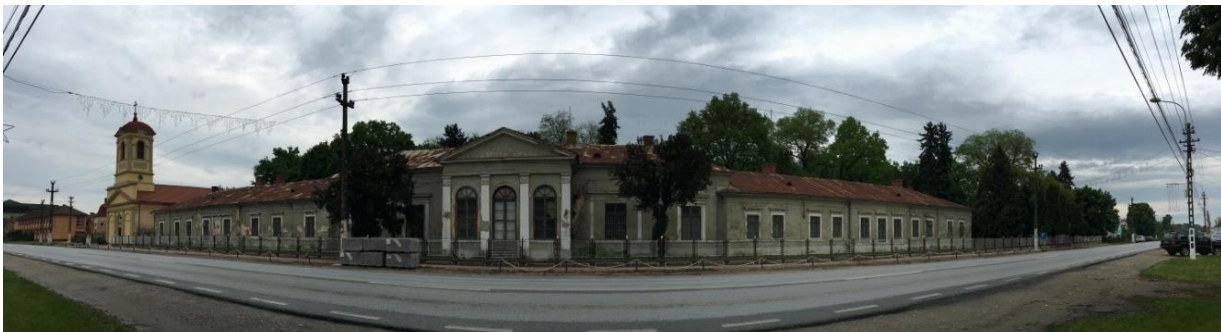
Fig. 7. The main facade of the Liphay mansion in Lovrin (2016). This photograph documents the condition before recent renovation efforts, showing the classical architectural elements and the symmetrical organization of openings that have been preserved throughout the building's history.

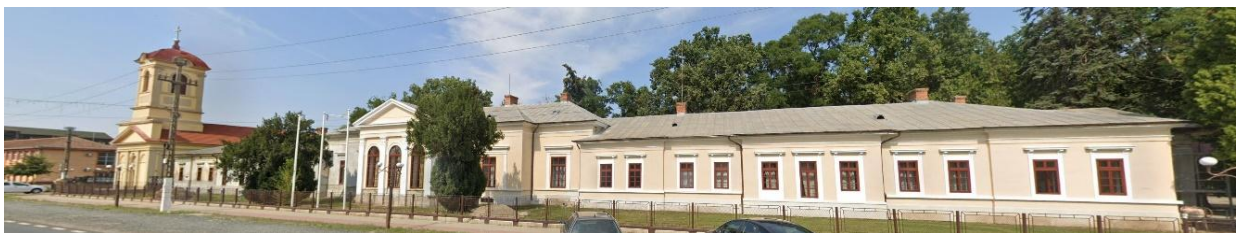
Fig. 8. The main facade of the Liphay mansion in Lovrin (2023), after renovation. The preservation of original architectural details during renovation work demonstrates increasing recognition of the site's heritage value and the implementation of appropriate conservation approaches.

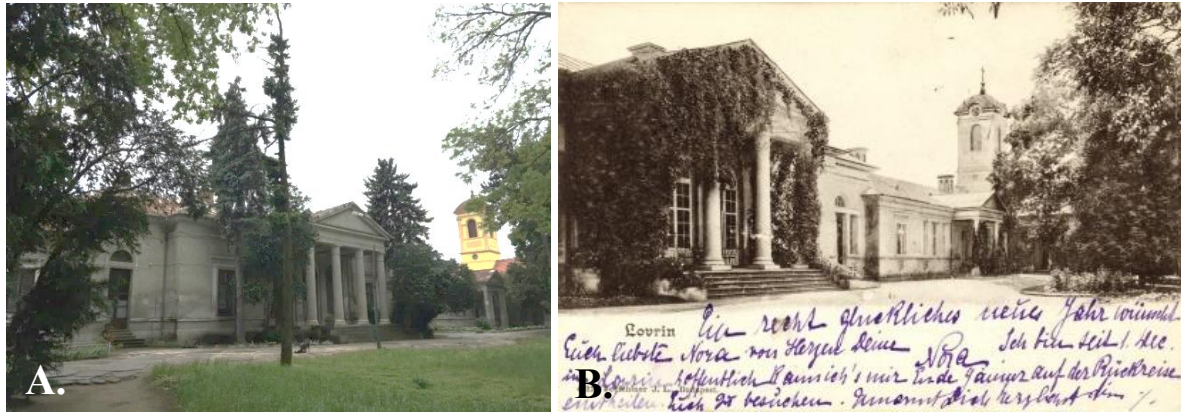
Fig. 9. The rear facade with main access to inner courtyard (author's photo, **A.**) compared with 1903 postcard (**B.**), illustrating remarkable preservation of architectural features over more than a century

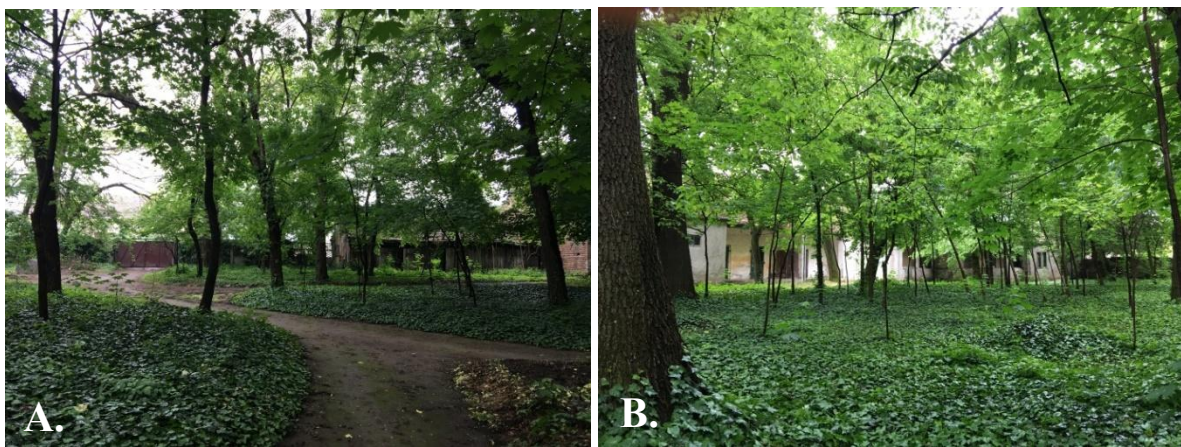
Fig. 10. Secondary access on the rear side of the property (**A.**) and the organization of existing pathways (**B.**) (the author's photos)
